Manhole Inspection Summary

Manhole # S37KK_018MH

Insp Date: **3/19/07 11:08 AM**

Location Address: **1718 BARCLAY ST**

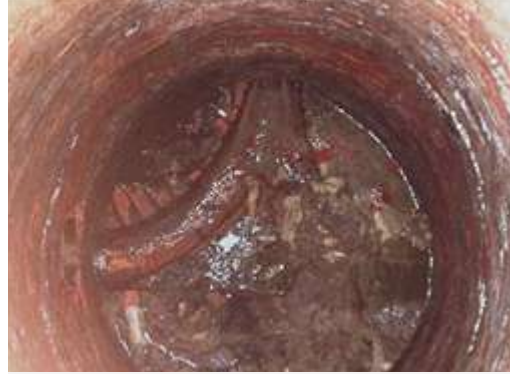
Top View

Bench and Channel debris.

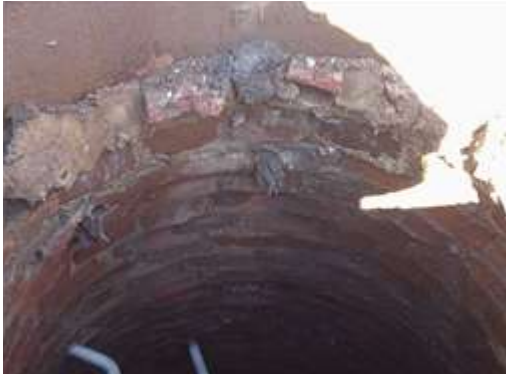
Defect

Missing steps. Frame leaks. Adjustment deterioration, loose brick and infiltration. Corbel and Barrel infiltration.

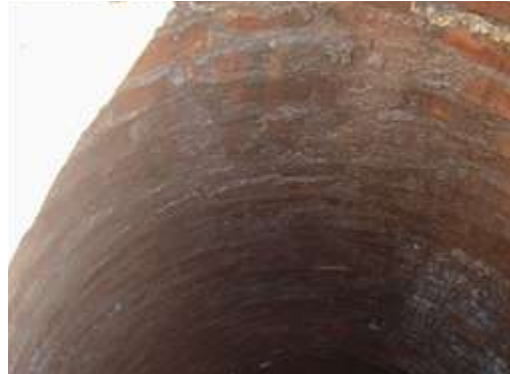
Defect

Adjustment deterioration and infiltration. Corbel and Barrel infiltration.

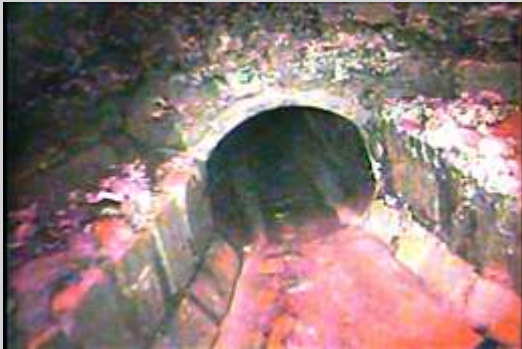
8 in. Circular Gravity Sewer Pipe Out @ 12 O'Clock

Barrel deterioration and infiltration. Channel deterioration.

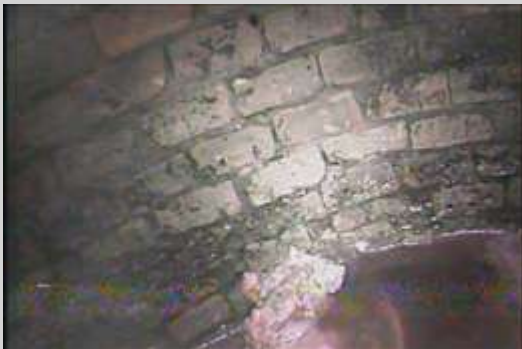
8 in. Circular Gravity Sewer Pipe In @ 3 O'Clock

Deposits: ☐ None ☒ **Mud** ☐ Sludge ☒ **Debris** ☒ **Grease**

Silt Depth: **8** (in.) Deposits Extent: **Heavy**

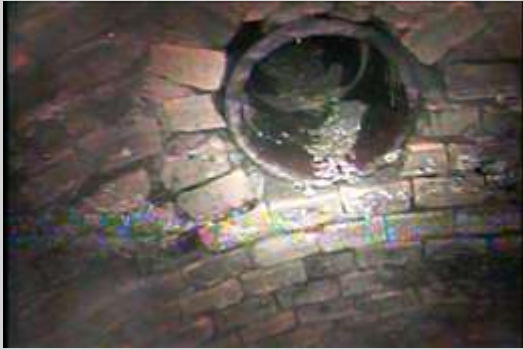
Pipe In @ 9 O'Clock

Barrel deterioration and infiltration.

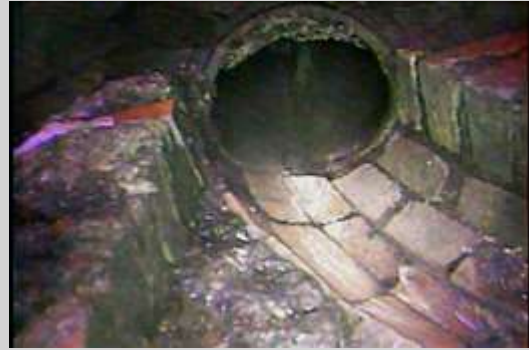
Drop In @ 9 O'Clock

Infiltration: **Evidence** Pipe Seal Cond: **Broken**
